Date: 14 Dec 2021

## PRE-2014 LH3600-5 YOKE SERVICE BULLETIN (REVISED)

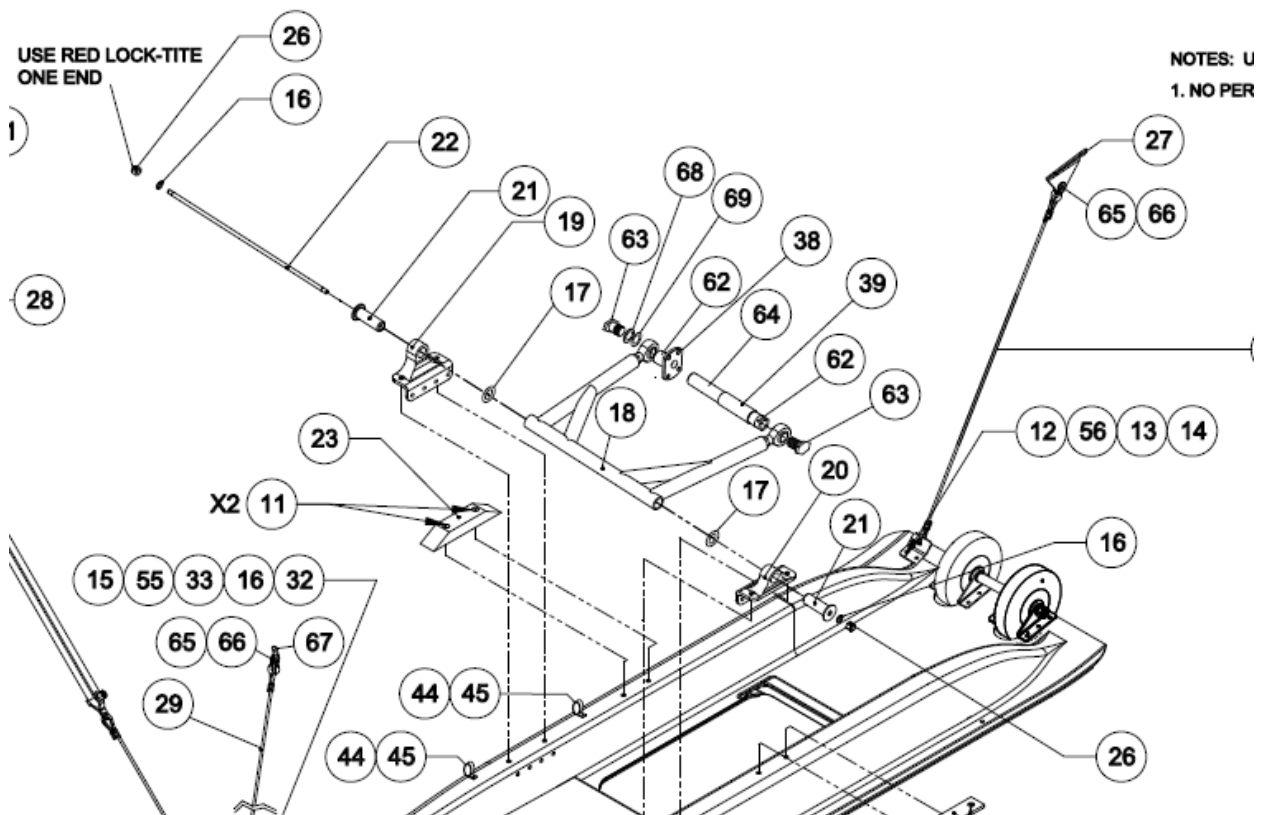
FIGURE 1

1. Prior to ski removal, disconnect all rigging, the aircraft can be hoisted or jacked to remove all rigging. We recommend removing rear check cable and forward safety cable first. Then aircraft can be hoisted or jacked to remove bungee cable. Rotating the ski down will relieve tension on the bungee for easier removal.
2. With ski supported, remove the two each NAS1312-15 bolts on each ski that go thru the CM-12 rod ends on yoke, see item 63 in figure 1.
3. Once rigging and NAS1312-15 bolts are removed, ski will be free of aircraft.
4. The next step is to remove the yokes from the skis. To do this (See Figure 1) remove axle rod nut (item 26). This will allow you to remove the axle rod (item 22), followed by the removal of the two buckets ((Item 21). The yoke will be free of the ski.

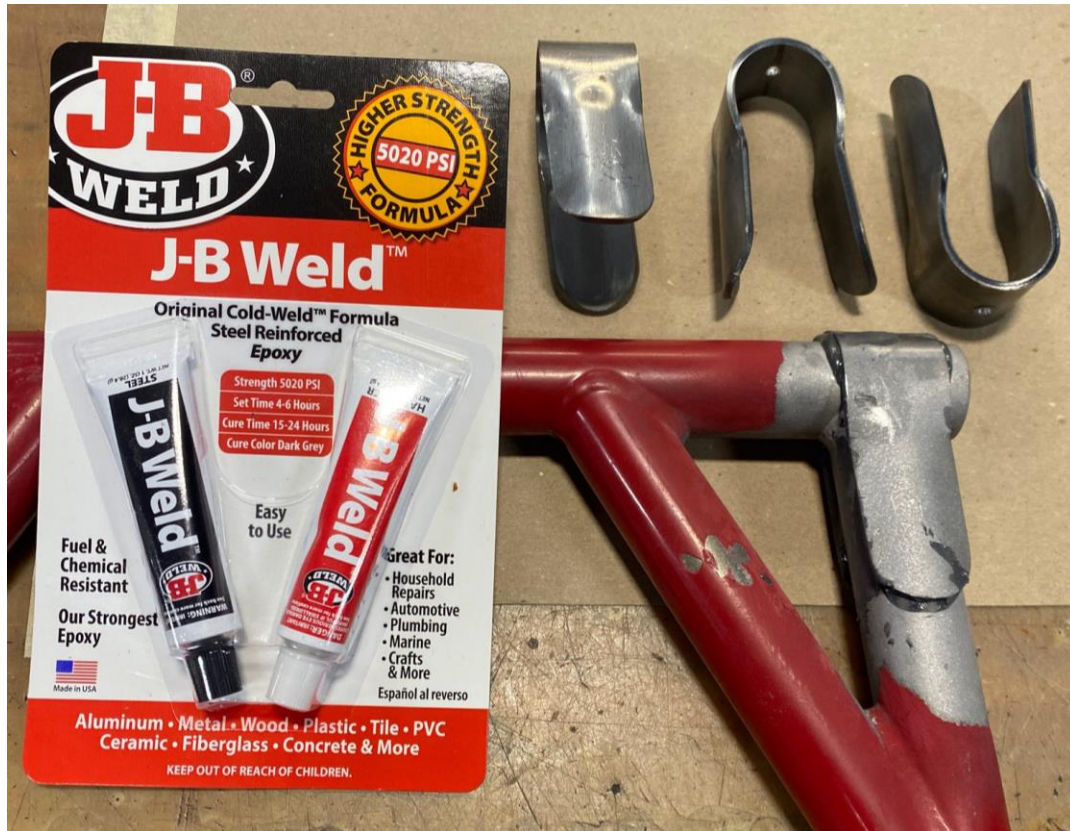
7. If no cracks are found, we recommend a 1" wide .100 4130N reinforcement strap be bonded onto the outboard yoke arms. This will be an intermediate fix for the yoke. . arm on outboard side of the yokes. **Bonded reinforcement straps will eliminate further weld inspection requirements, unless damage occurs to the bond line of the reinforcement.**

1. Completely blast the yoke, in the area of the bond, to remove all powder coat in the area.
2. Blast the reinforcement straps completely.
3. Clean yoke and reinforcement strap with acetone or MEK.
4. Thoroughly mix adhesive 1 to 1 according to package instructions. Ensure mix is a consistent gray color.
5. Apply adhesive to the reinforcement strap liberally to the inside of the strap. Note: you should see squeeze out of adhesive during clamp up.
6. Install the strap onto the yoke. Use a pair of vise grips to clamp fingers of the reinforcement straps to the yoke.
7. Use squeeze-out adhesive to smooth around edges of the reinforcement straps.
8. Clean any excess adhesive with acetone or MEK.
9. Allow reinforcement straps to cure for at least 24 hours.
