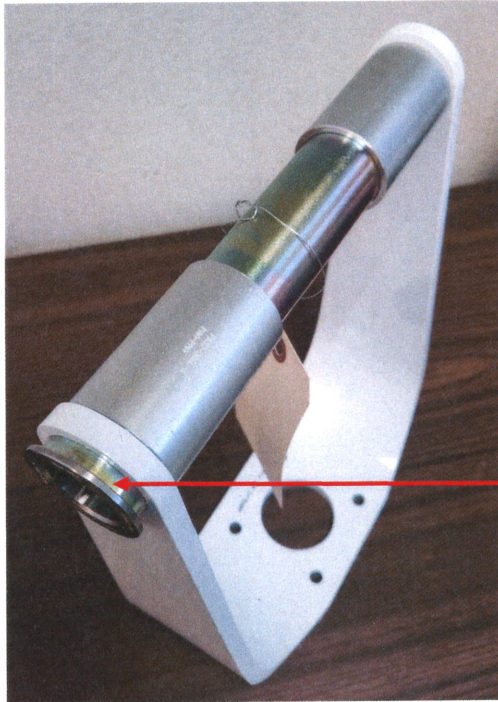
**IMPROPER INSTALLATION: AXLE TUBE IS NOT INSERTED ON BOTH SIDES OF THE FORK. NOTE THE AXLE TUBE STICKING OUT ON ONE SIDE. THIS CONDITION WILL CREATE ISSUES WITH GETTING PROPER TENSION ON BEARING WASHER. THE TUBE ON THE SIDE THAT IS NOT INSERTED INTO FORK WILL PREVENT YOU FROM TIGHTENING THE AXLE ROD. NOTE: IT IS HARD TO SEE THIS CONDITION WITH WHEEL INSTALLED. THE STICKING OUT OF THE AXLE TUBE IS THE INDICATOR OF THE PROBLEM.**

MAKE SURE BEARING WASHER IS UNDER ADEQUATE TENSION TO PREVENT IT FROM SPINNING AS WHEEL IS TURNED. FAILURE TO GET ADEQUATE PRELOAD WILL CAUSE WHEEL TO SPIN THE BEARING WASHER, VERSUS THE BEARING. WITH OUR STYLE OF NUT, YOU DO NOT BACK OFF AFTER PRELOAD IS APPLIED TO BEARING WASHER.

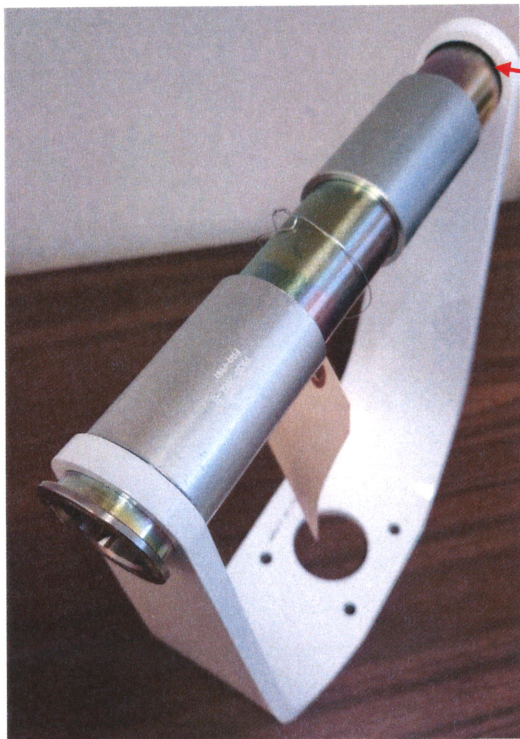
BEARING WASHER

**NOTE: THE AXLE TUBE IS STICKING OUT ON ONE SIDE.**

**VIEW WITH LARGE SPACER PULLED OUT OF THE WAY.**
