**Subject: Troubleshooting of GLH3000 skis on Piper type geared aircraft.**

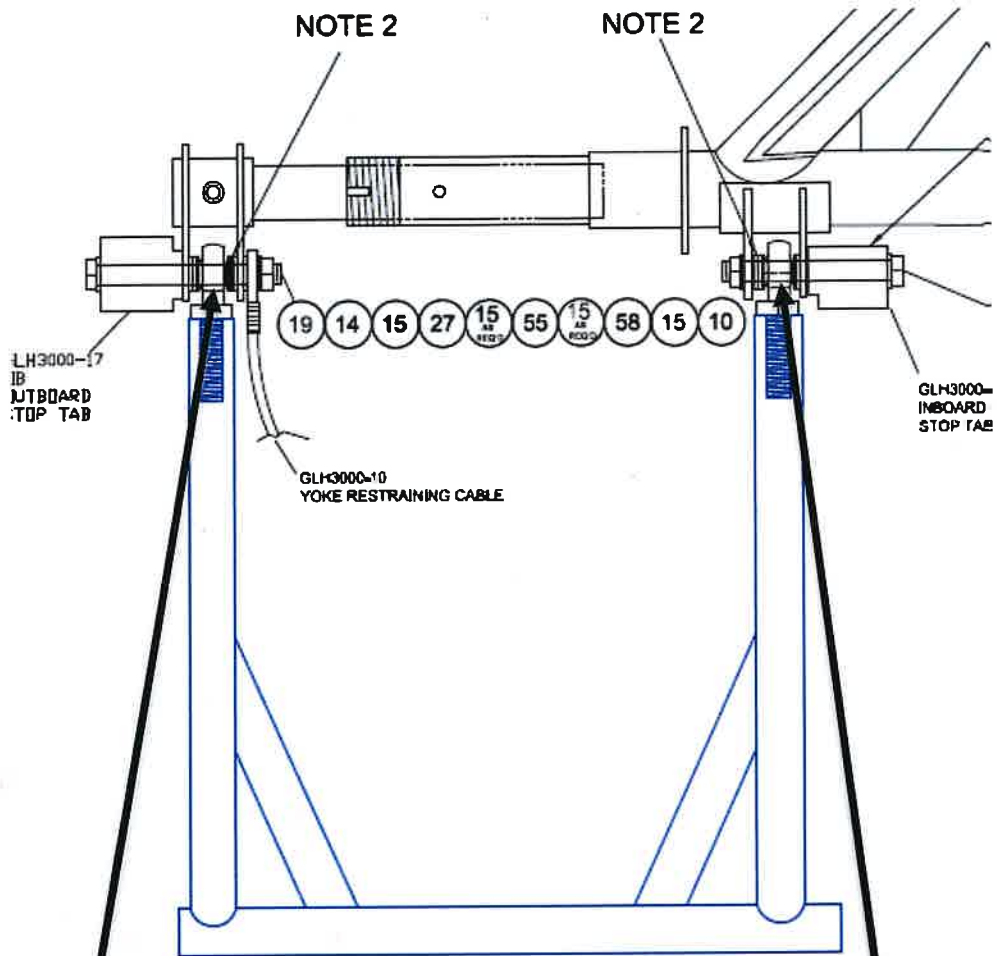
Reduce the outboard rod end, to reduce toe-in condition. Option 1

Extend the inboard rod end to reduce toe-in condition. Option 2

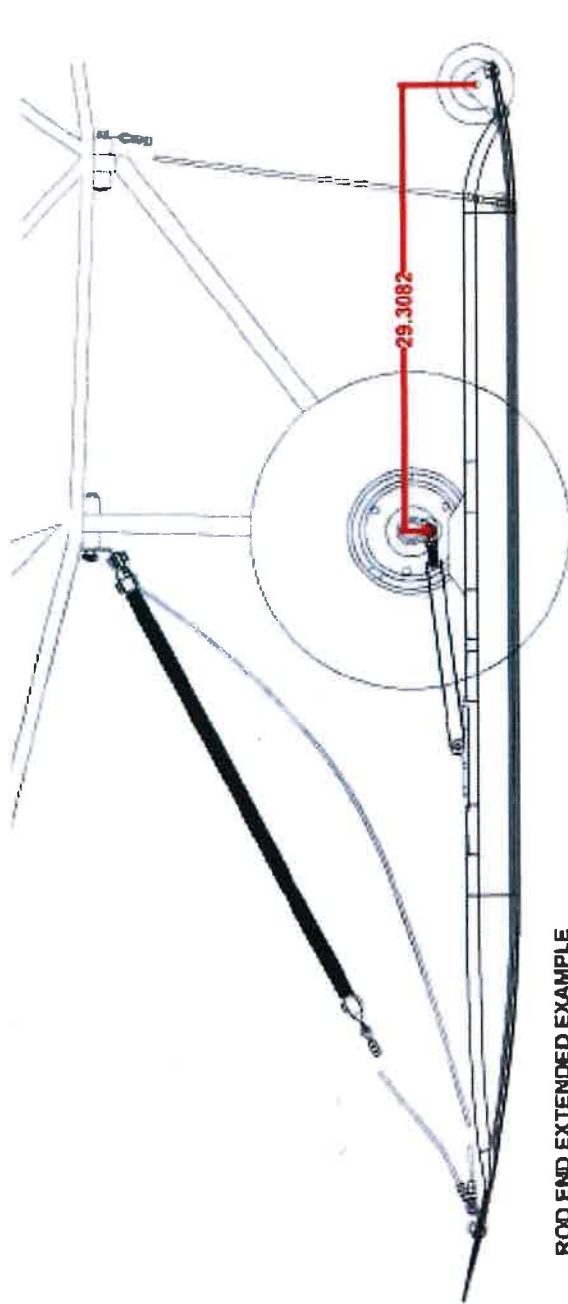
**ROD END EXTENDED EXAMPLE**  
NOTE: SKI ASSEMBLY MOVES FORWARD. THIS REDUCES DISTANCE (GAP) AT THE BACK OF WHEEL WELL BETWEEN TIRE AND SKI.

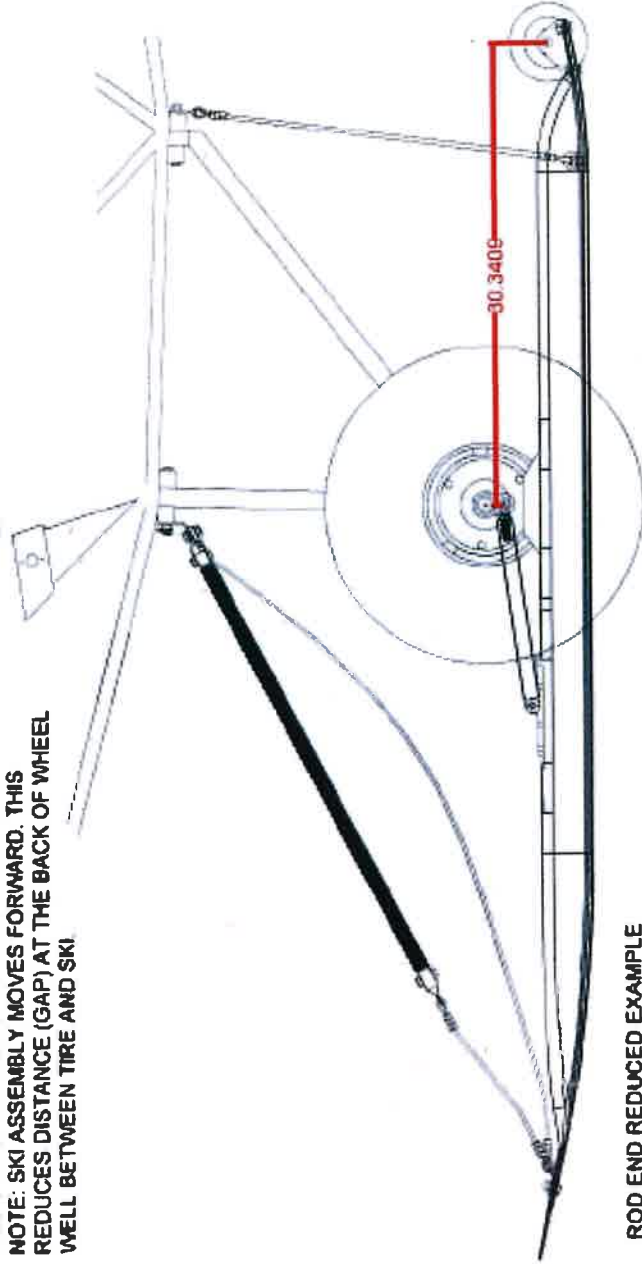
**ROD END REDUCED EXAMPLE**  
NOTE: SKI ASSEMBLY MOVES AFT. THIS INCREASES DISTANCE (GAP) AT THE BACK OF WHEEL WELL BETWEEN THE TIRE AND SKI.
