Date: 14 Dec 2021

## PRE-2014 LH3600-5 YOKE SERVICE BULLETIN (REVISED)

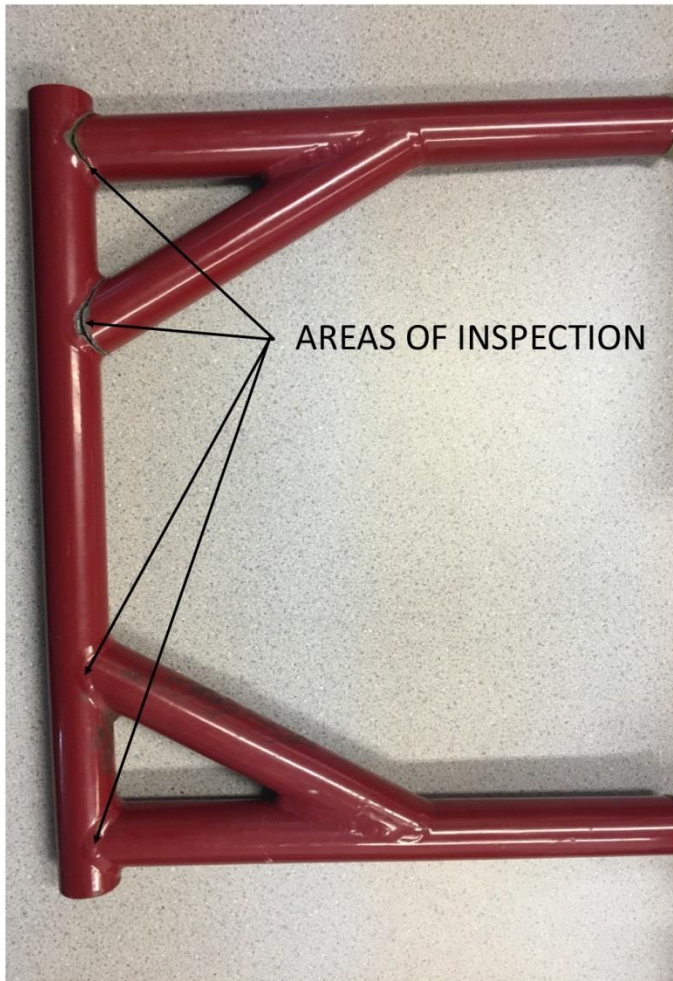
Airglas has received 5 reports of the LH4000 yoke (PN LH3600-5) of the welds shearing off the outboard arm of the yoke. The common thread between all occurrences is a heavy side load is applied to the skis. This sideways load appears to happen in a turn. In three cases, pilot reported to Airglas that they hit an obstruction in a turn. In the latest case, the check cable came loose in flight and hung vertical in flight. This vertical position created exponential forces due to the additional arm of

7. If no cracks are found, we recommend a 1" wide .100 4130N reinforcement strap be bonded onto the outboard yoke arms. This will be an intermediate fix for the yoke. . arm on outboard side of the yokes. **Bonded reinforcement straps will eliminate further weld inspection requirements, unless damage occurs to the bond line of the reinforcement.**

8. The **best option** is to replace yokes with current generation yokes. Current generation yokes are of much higher strength and very resistant to high sideward shock loads. These yokes are not heat-treated and have internal build-ups. The lack of heat treatment makes them more ductile. This is the best option to prevent future cracking problems. Airglas will offer yokes at a low cost for 24 months from the date of this Service Bulletin.
