[Docket No. 97-CE-138-AD; Amendment 39-10865; AD 98-23-02]

**Airworthiness Directives; Cessna Aircraft Company 180 and 185 Series Airplanes**

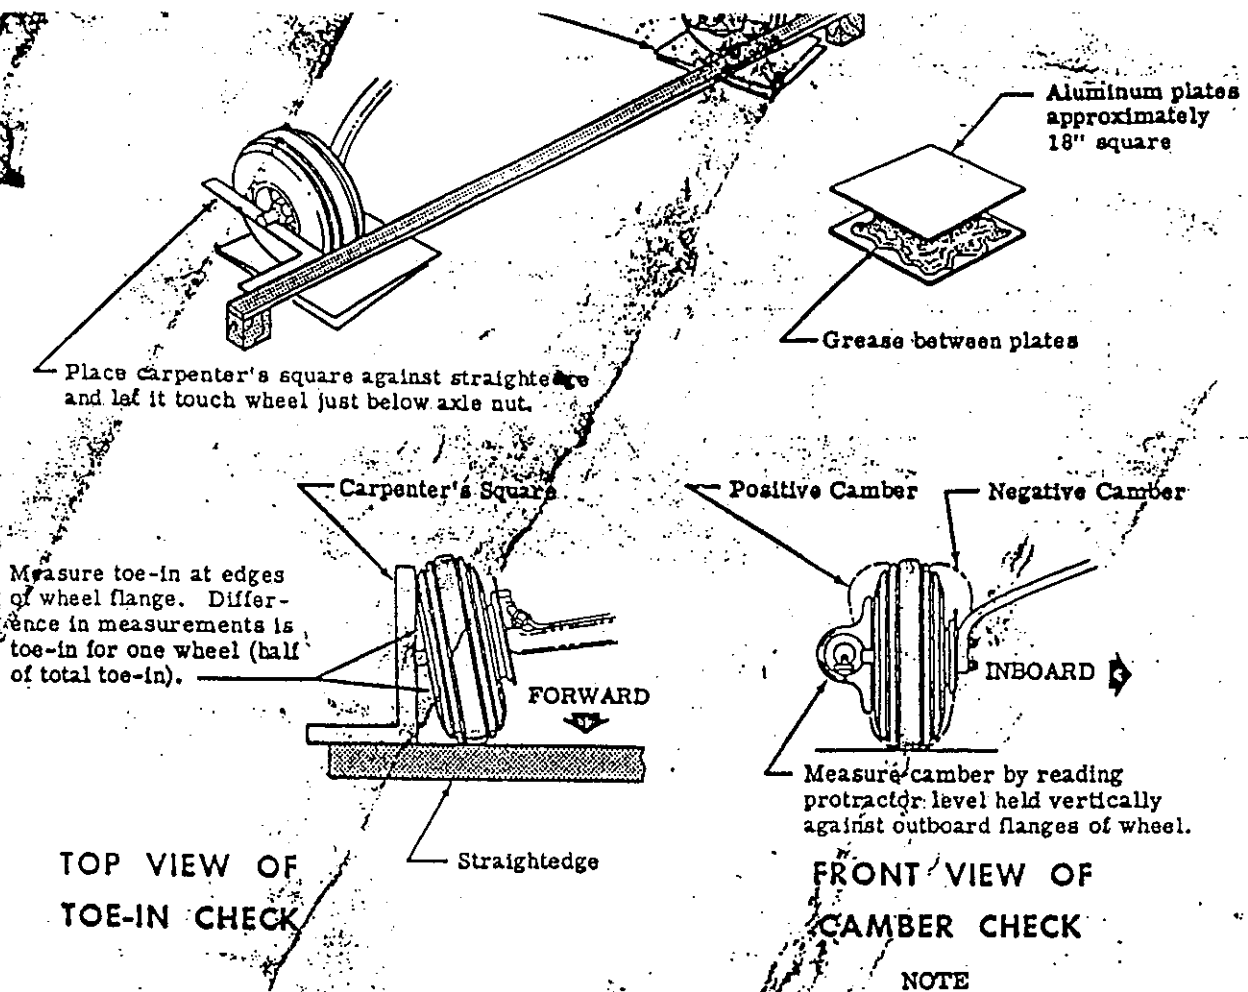
AIRPLANE MODEL	TOTAL TOE-IN	POSITIVE CAMBER
150	0" to .06"	4° to 6°
172	0" to .06"	3° to 5°
P172	0" to .06"	3° to 5°
180	0" to .12"	4° to 6°
182	0" to .06"	5° to 7°
185	0" to .12"	4° to 6°

Setting toe-in and camber in accordance with the chart while the cabin and fuel tanks are empty will give approximately zero toe-in and zero camber at gross weight. Ideal setting is zero toe-in and zero camber at normal operating weight. Therefore, if normal operation is at less than gross weight and abnormal tire wear occurs, realign the wheels to attain the ideal setting for the load condition under which the airplane normally operates.

The maximum accumulated shim thickness, measured at the thickest corner (do not include any speed fairing plates or cover plates), is .22 inch for all except the Model 182. Refer to sheet 3 for shim combinations permitted on the Model 182. Always use the least number of shims possible to obtain the desired result.
